## Geomorphology of the Maribyrnong River, Victoria

Melbourne Water

Fluvial Systems Pty Ltd

July 2000

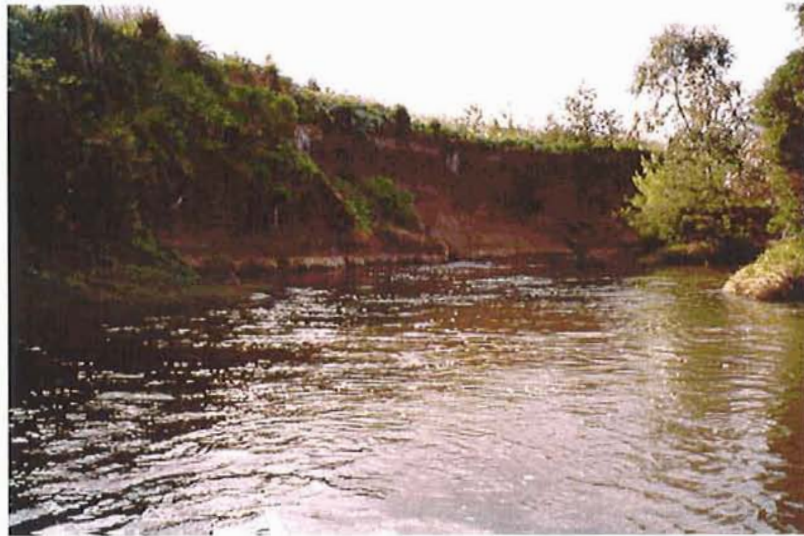
**Figure 6. Site 59 (9.9 km) looking upstream in 1990 (Camp Scott Furphy 1990).**

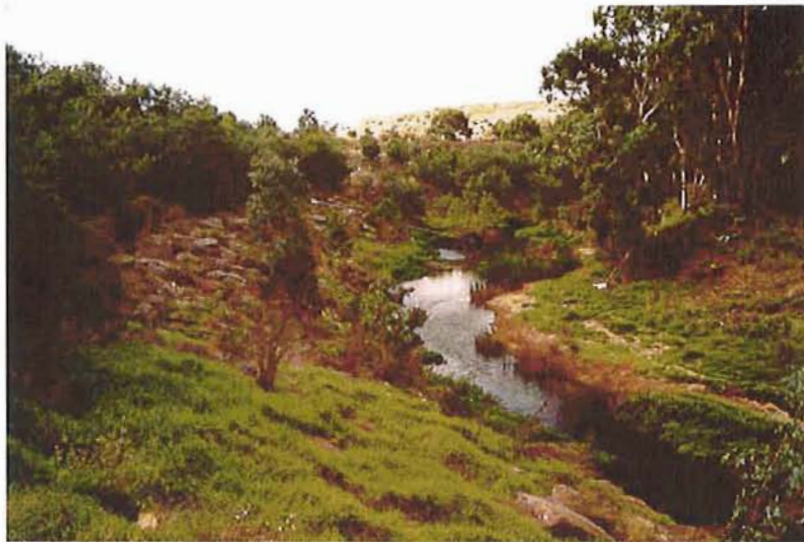
**Figure 7. Site 59 (chainage 9.9 km) looking upstream in 1999 (after works).**

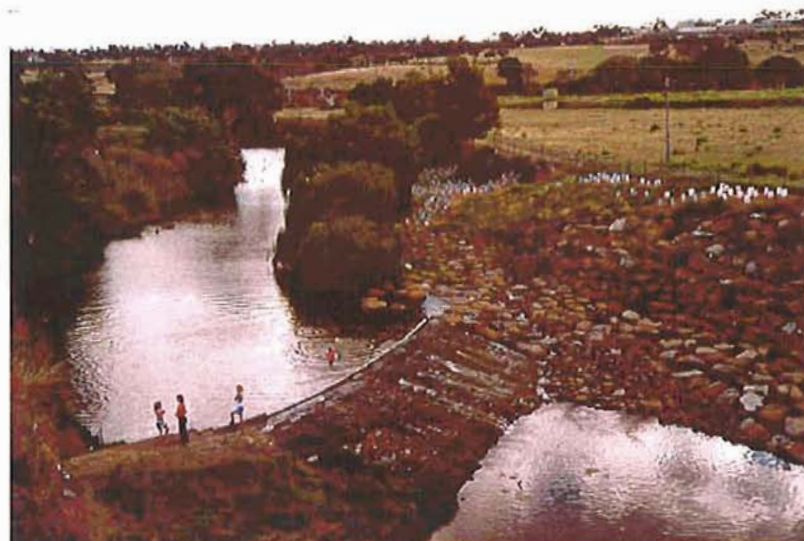
**Figure 8. Arundel Street weir looking upstream (chainage 12 km), with recently installed fishway on left bank.**

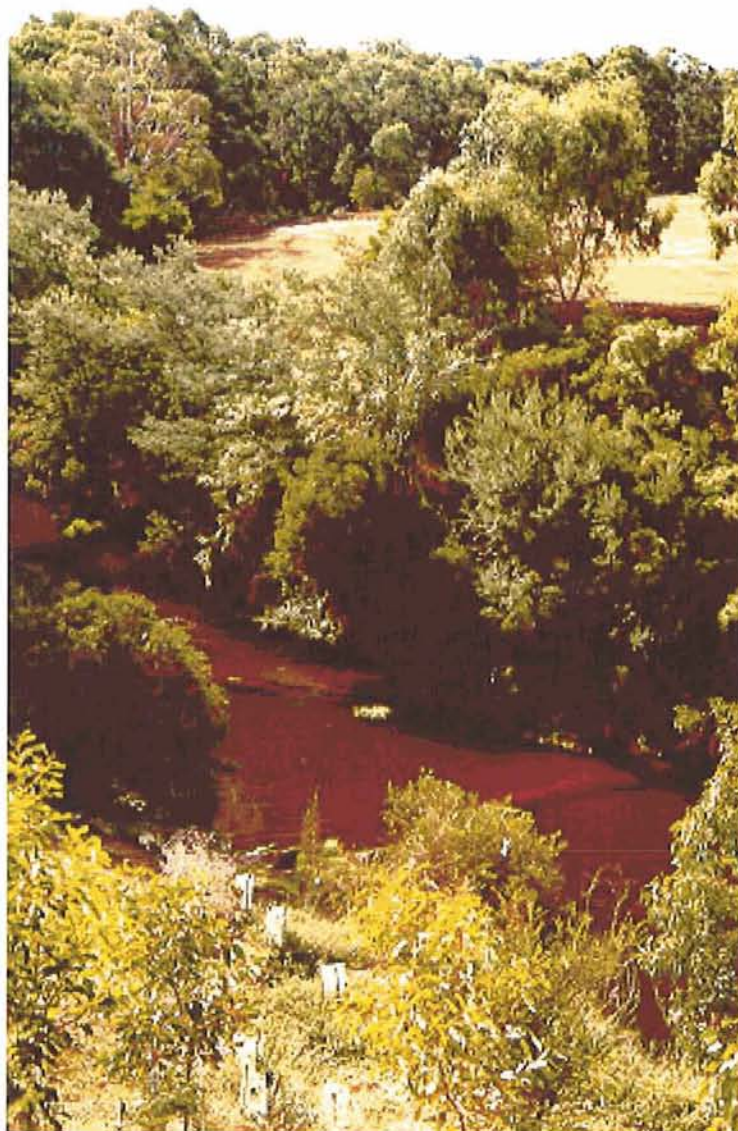
**Figure 23. Soil quarry near Flora Street (chainage 9.5 – 10.0 km). Also, note rock bars in channel.**

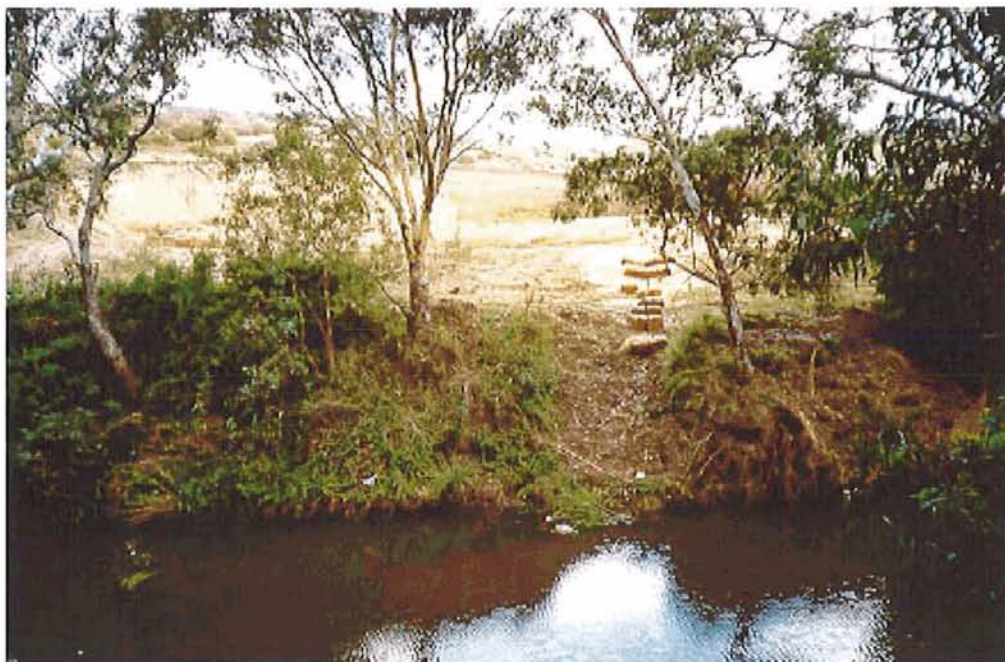
**Figure 24. Drainage line directed to Maribyrnong River from disturbed soil area on right floodplain about 1 km upstream of Trestle Bridge.**

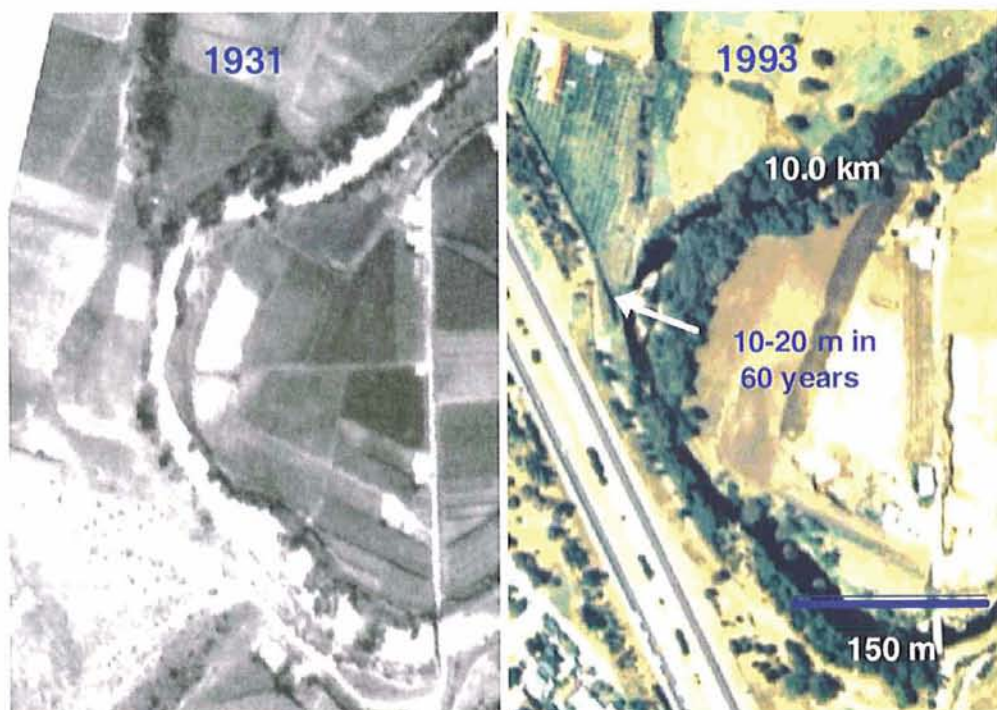
**Figure 25.** Comparison of Maribyrnong River channel in vicinity of Calder Freeway (9.5 – 10.0 km) in 1931 and 1993, showing area of channel migration.

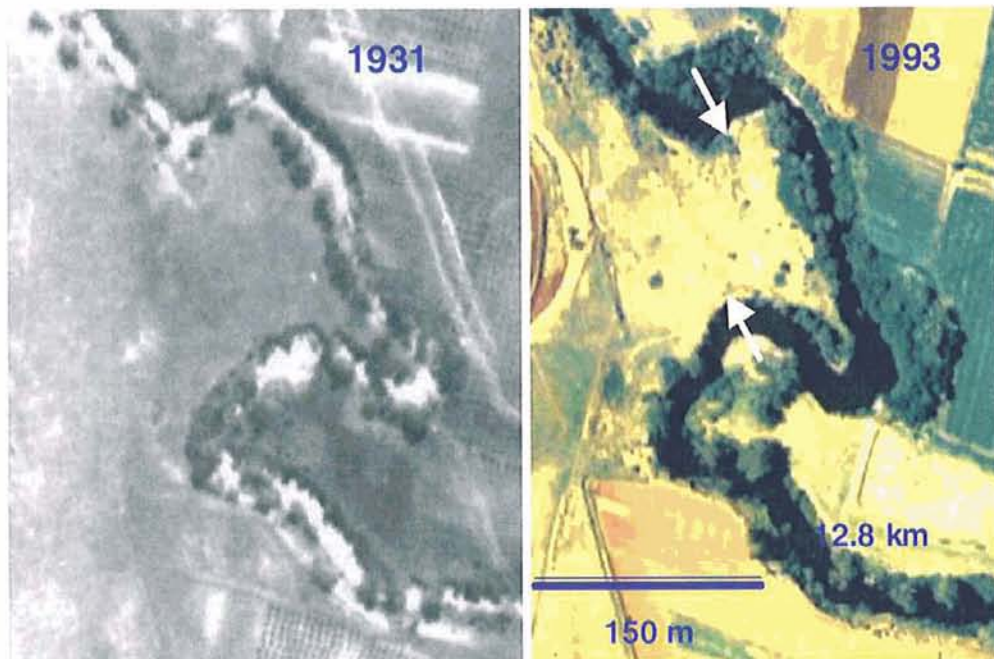
**Figure 26.** Comparison of Maribyrnong River channel in vicinity of Brown's property (12.8 – 13.5 km) in 1931 and 1993, showing areas of channel migration.

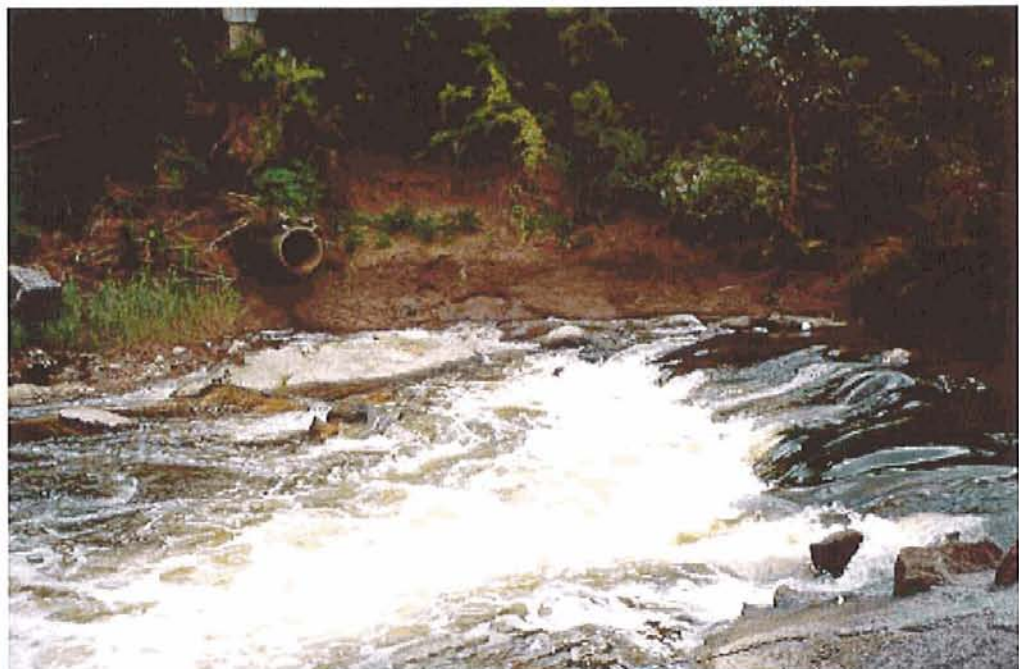
**Figure 27.** Milburns Weir (chainage 13.8 km) looking towards right bank in 1990.

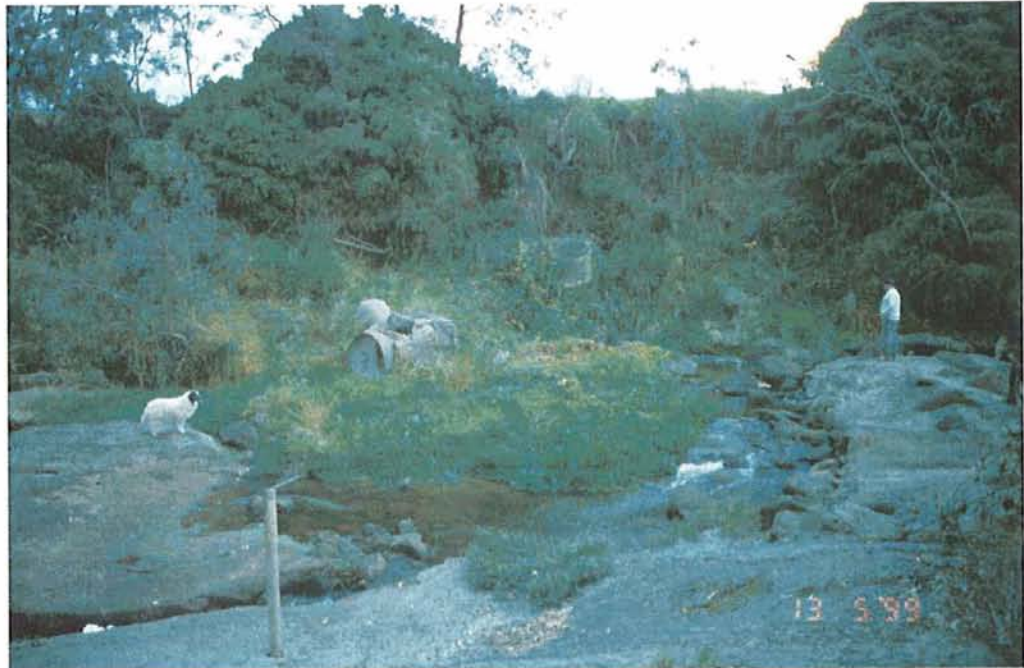
**Figure 28. Milburns Weir (chainage 13.8 km) looking towards right bank in 1999.**

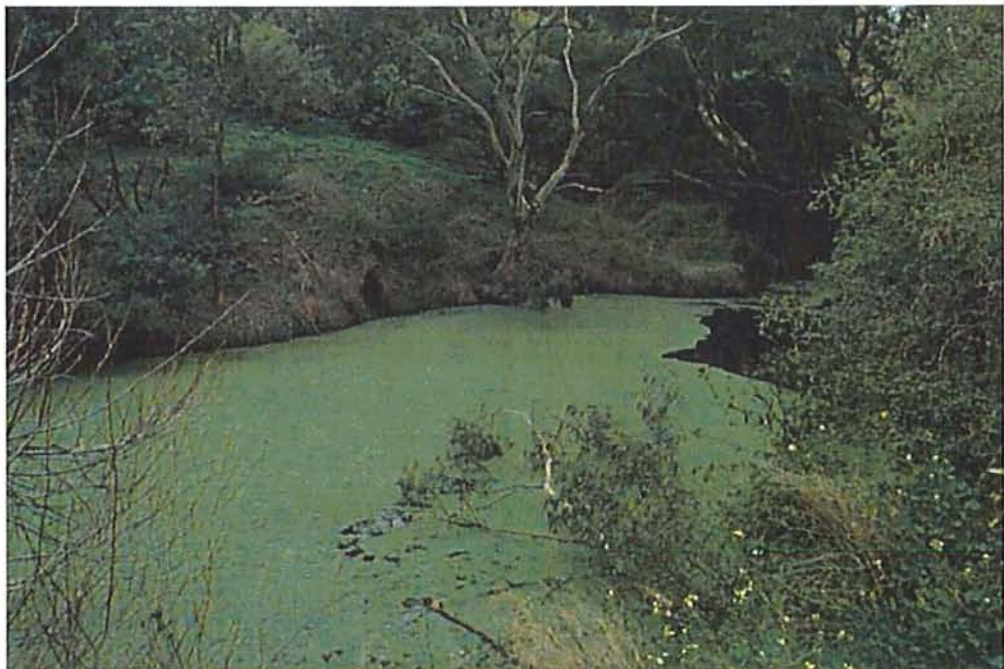
**Figure 37.** Floating mass of *Azolla filiculoides* in the Maribyrnong River at Sydenham on 10 June 1999.

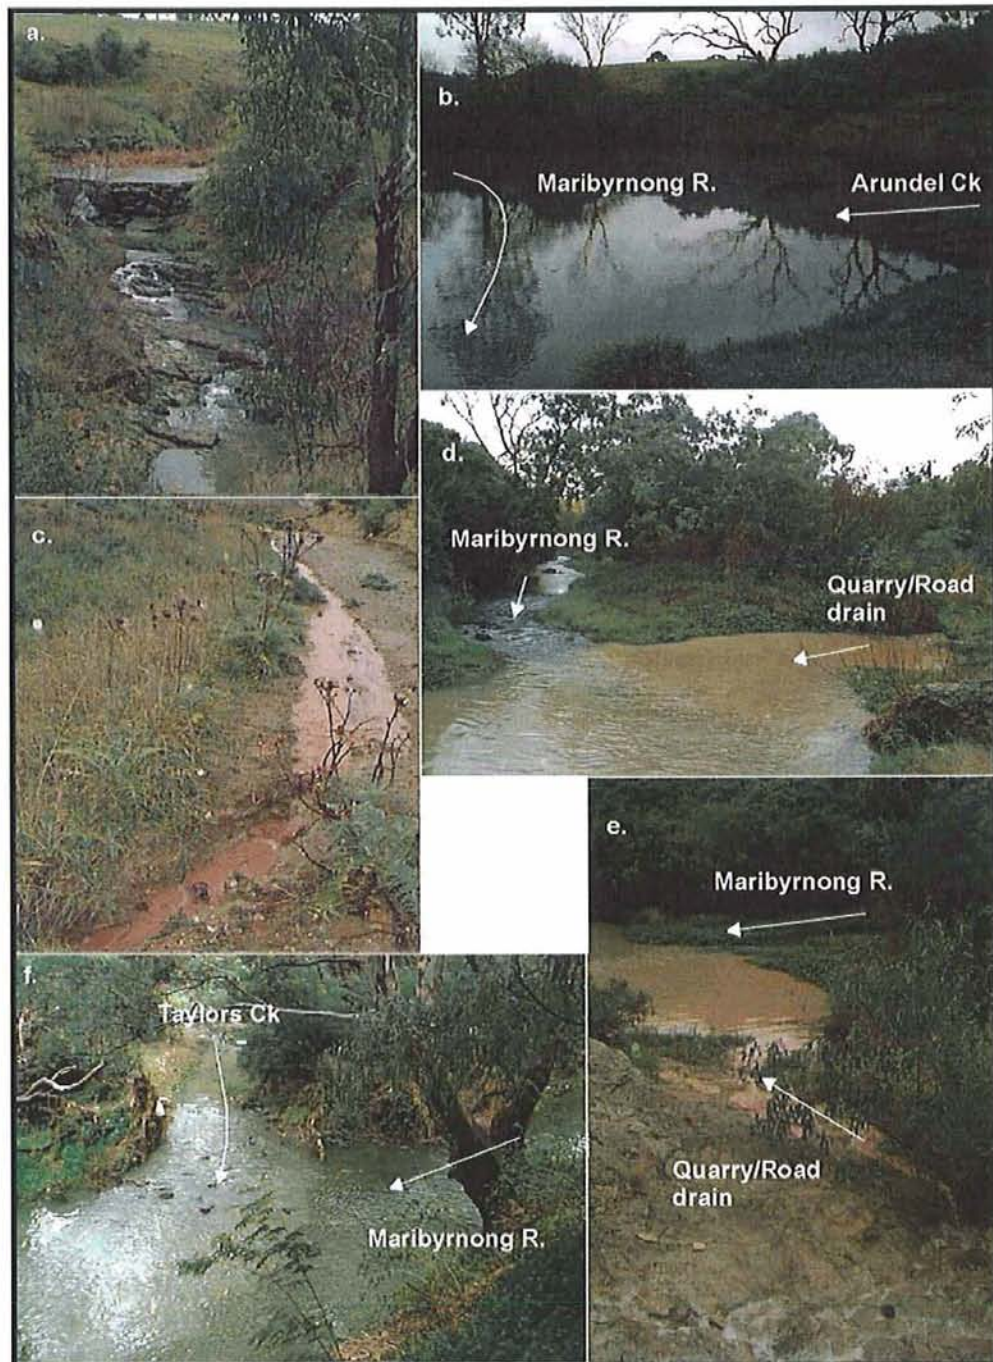
**Figure 38.** Confluences of the Maribyrnong River with urban tributaries on 11 June 1999, after ~15mm of rain fell across the lower urban catchment in previous 18 h. *a.* Arundel Ck, just upstream of the confluence; *b.* confluence with Arundel Ck; *c.* Gully draining quarry and road ~50m downstream of confluence with Arundel Ck; *d, e.* confluence with the quarry drain; *f.* confluence with Taylors Ck.

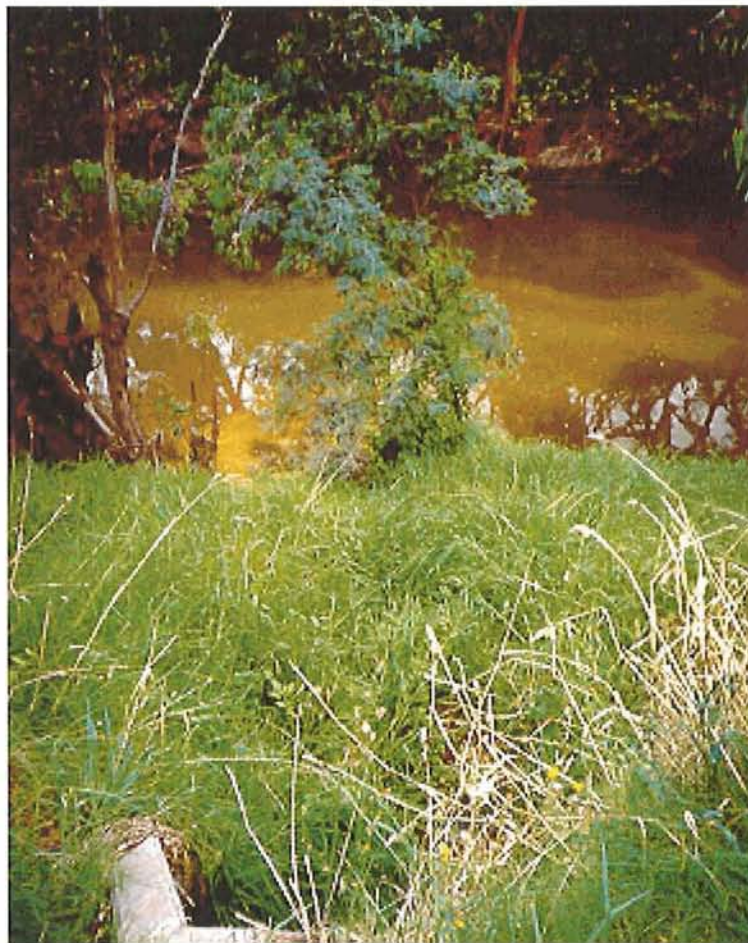
**Figure 40. Drain located 20 m downstream of the Trestle Bridge (left bank) contributing turbid runoff to the Maribyrnong River during low flow on 11<sup>th</sup> March 2000.**
