Geomorphology of the Maribyrnong River, Victoria

Melbourne Water

Fluvial Systems Pty Ltd

July 2000

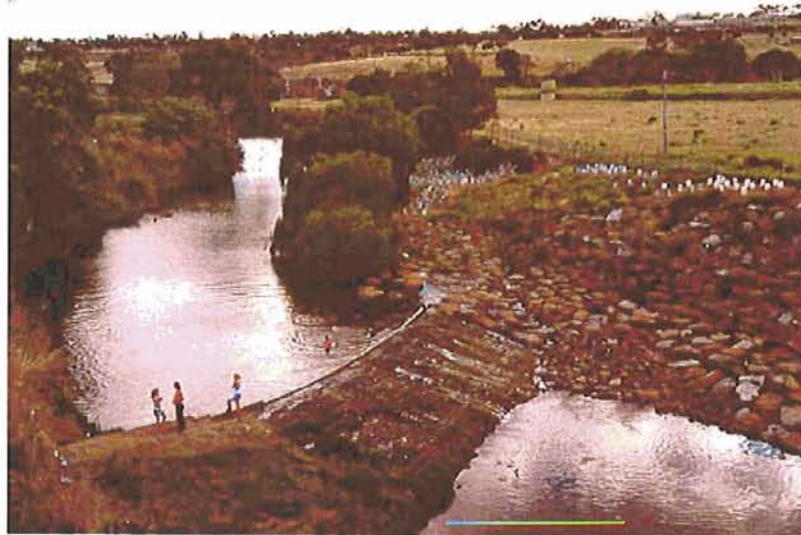
Arundel Street Weir with recently installed fishway (C. Gippel, 1999).
