Geomorphology of the Maribyrnong River, Victoria

Melbourne Water

Fluvial Systems Pty Ltd

July 2000

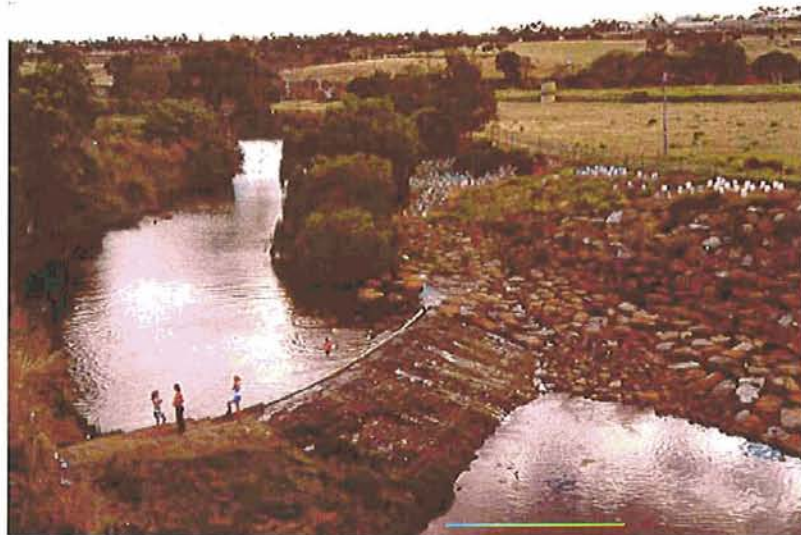
Arundel Street Weir with recently installed fishway (C. Gippel, 1999).

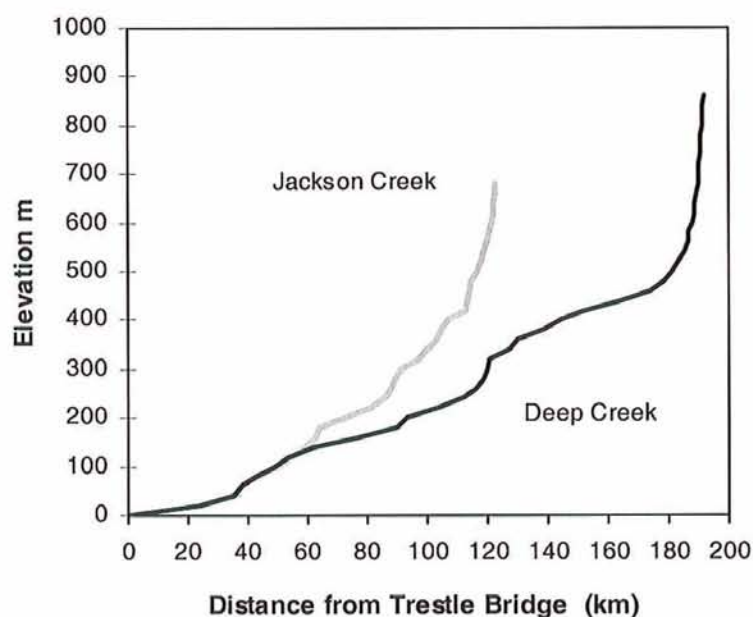
Figure 1. Long profile of Jacksons and Deep Creeks (confluence at approx. 20 km chainage).

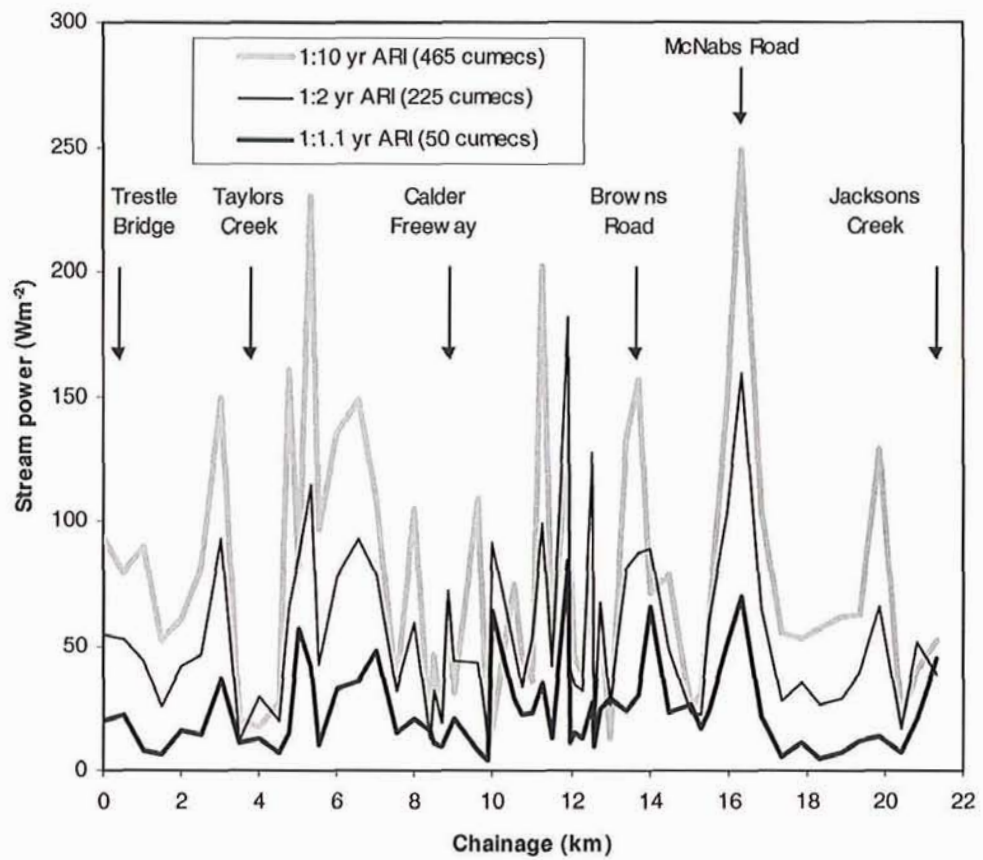
Figure 2. Variation in mean stream power for a range of discharges on the Maribyrnong River between the Trestle Bridge and the junction of Jacksons and Deep Creeks.

The mean stream power varied spatially, and as a function of discharge (Figure 2). The channel mean stream power exceeded 50 Wm^{-2} over about half of the reach length for the 1:2 yr ARI flood event. The stream power did not increase very much beyond that experienced for the 1:5 yr ARI event, because higher discharges spilled onto the floodplain. However, these floods produced high stream powers exceeding 100 Wm^{-2} at a few locations.

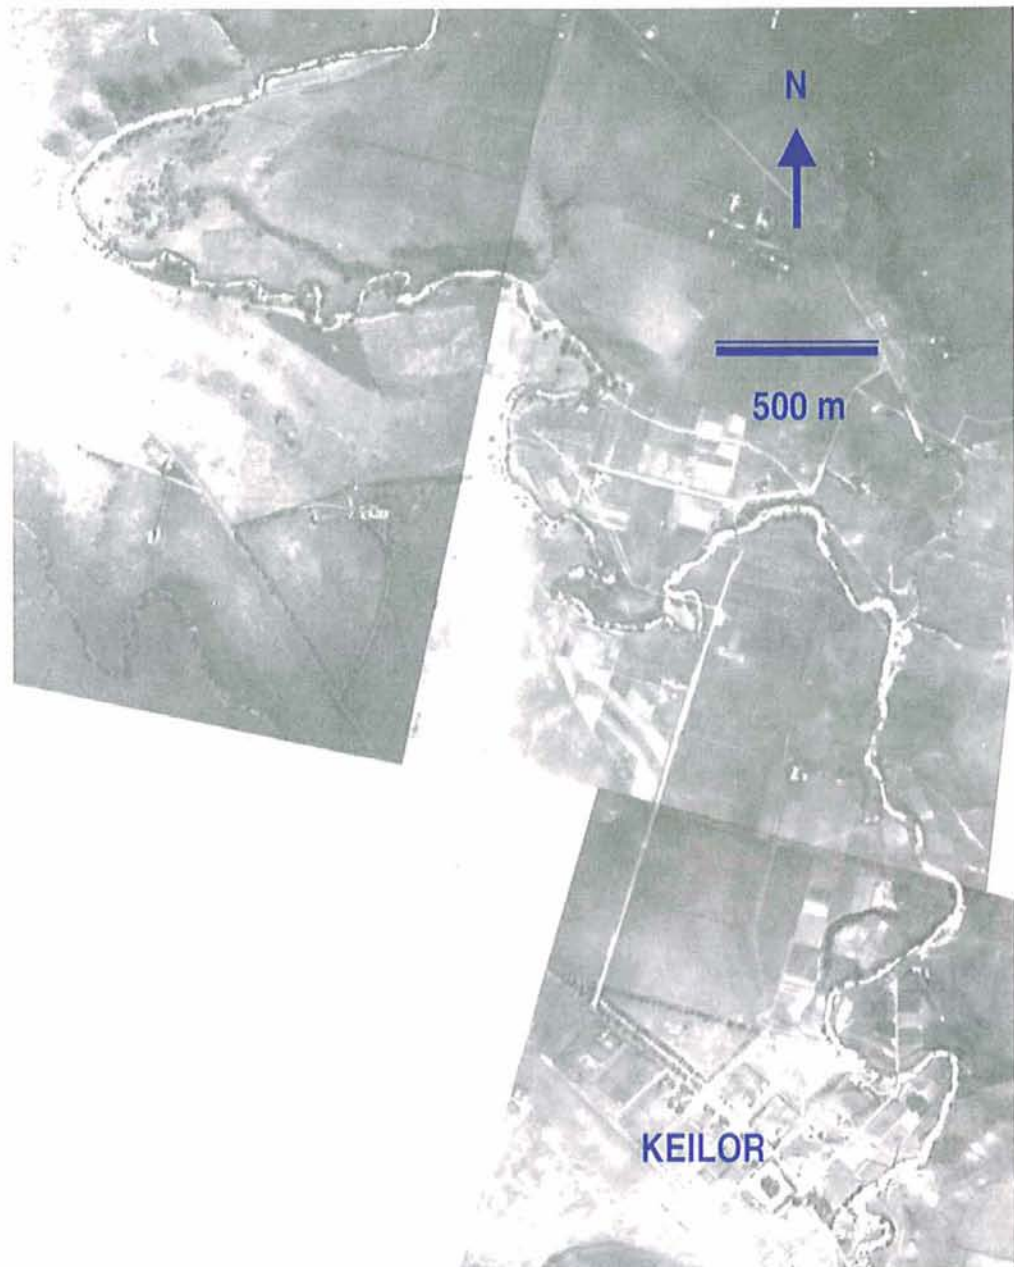
Figure 4. 1931 aerial photograph of Keilor reach of Maribyrnong River (MMBW Aero 2,13/4/1931, Runs 15, 16 & 17. 12:00 hrs No. 03452).

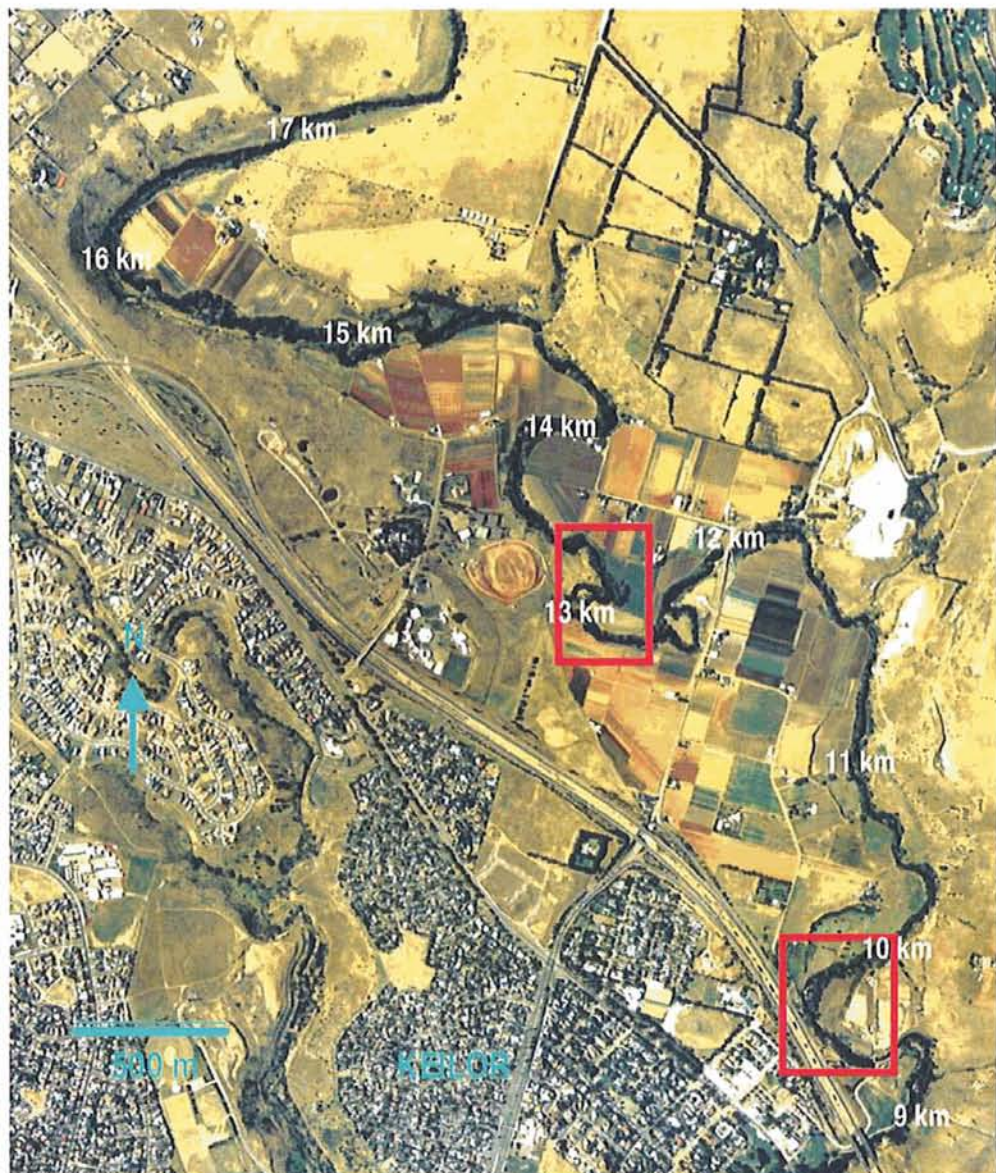
Figure 5. 1993 aerial photograph of Keilor reach of Maribyrnong River. Chainage is zero from Railway Trestle Bridge. Framed reaches are magnified in Figs 25 and 26.

Following the report of Camp Scott Furphy (1990), approximately 1000 m of river bank (representing 5 sites) were treated at a cost of \$1M (Fisher 1999). Camp Scott Furphy (1990) recommended soft engineering solutions such as timber groynes, but site difficulties deemed this approach impractical. After some initial failures using single sized rocks placed over geotextiles, the favoured technology was to first batter the banks, lay down a 300 mm thick filter layer of crushed rock, then key in larger rocks of mixed sizes. Topsoil was placed across the upper rock work. The crushed rock filter allowed riparian plants to recolonise. The five sites treated to date are (see Figure 5):

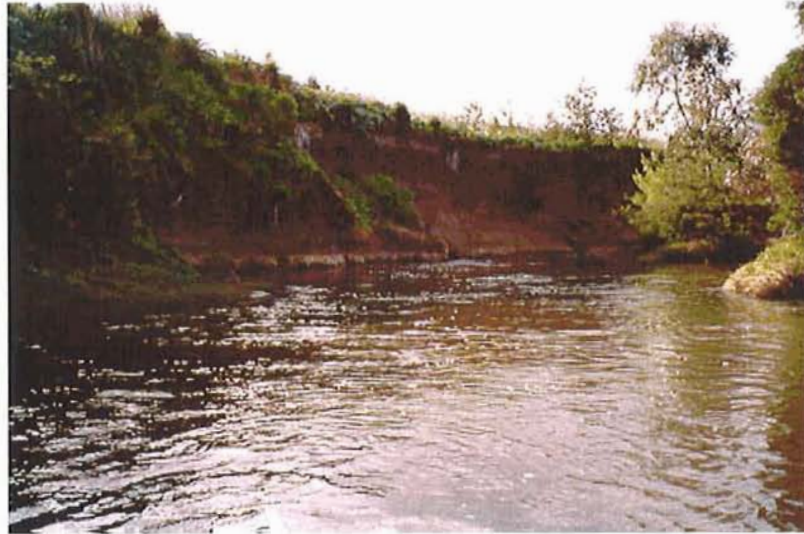
Figure 6. Site 59 (9.9 km) looking upstream in 1990 (Camp Scott Furphy 1990).

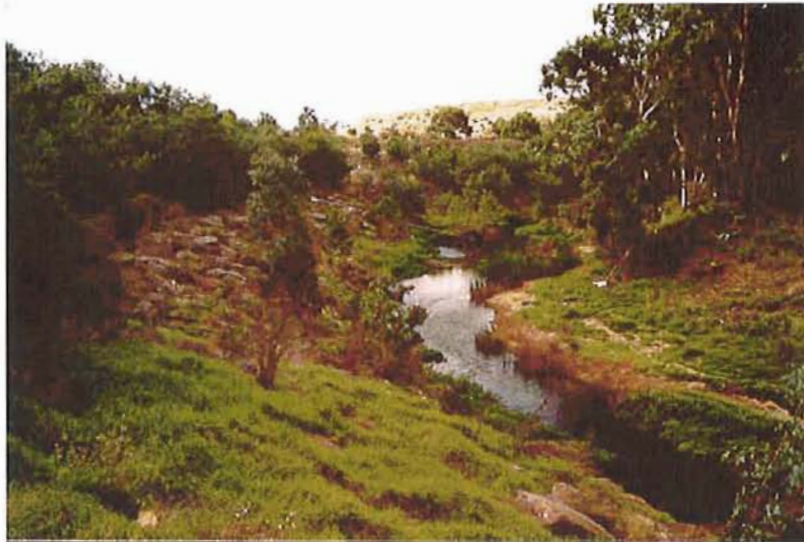
Figure 7. Site 59 (chainage 9.9 km) looking upstream in 1999 (after works).

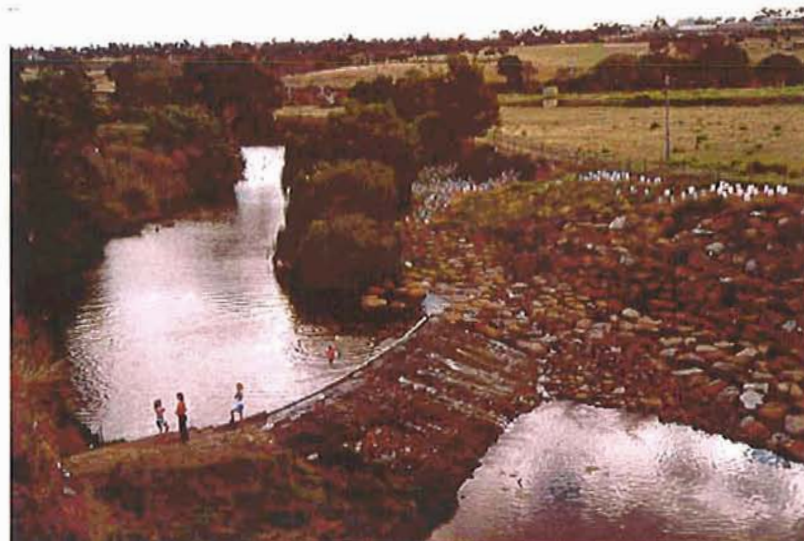
Figure 8. Arundel Street weir looking upstream (chainage 12 km), with recently installed fishway on left bank.
