## Geomorphology of the Maribyrnong River, Victoria

Melbourne Water

Fluvial Systems Pty Ltd

July 2000

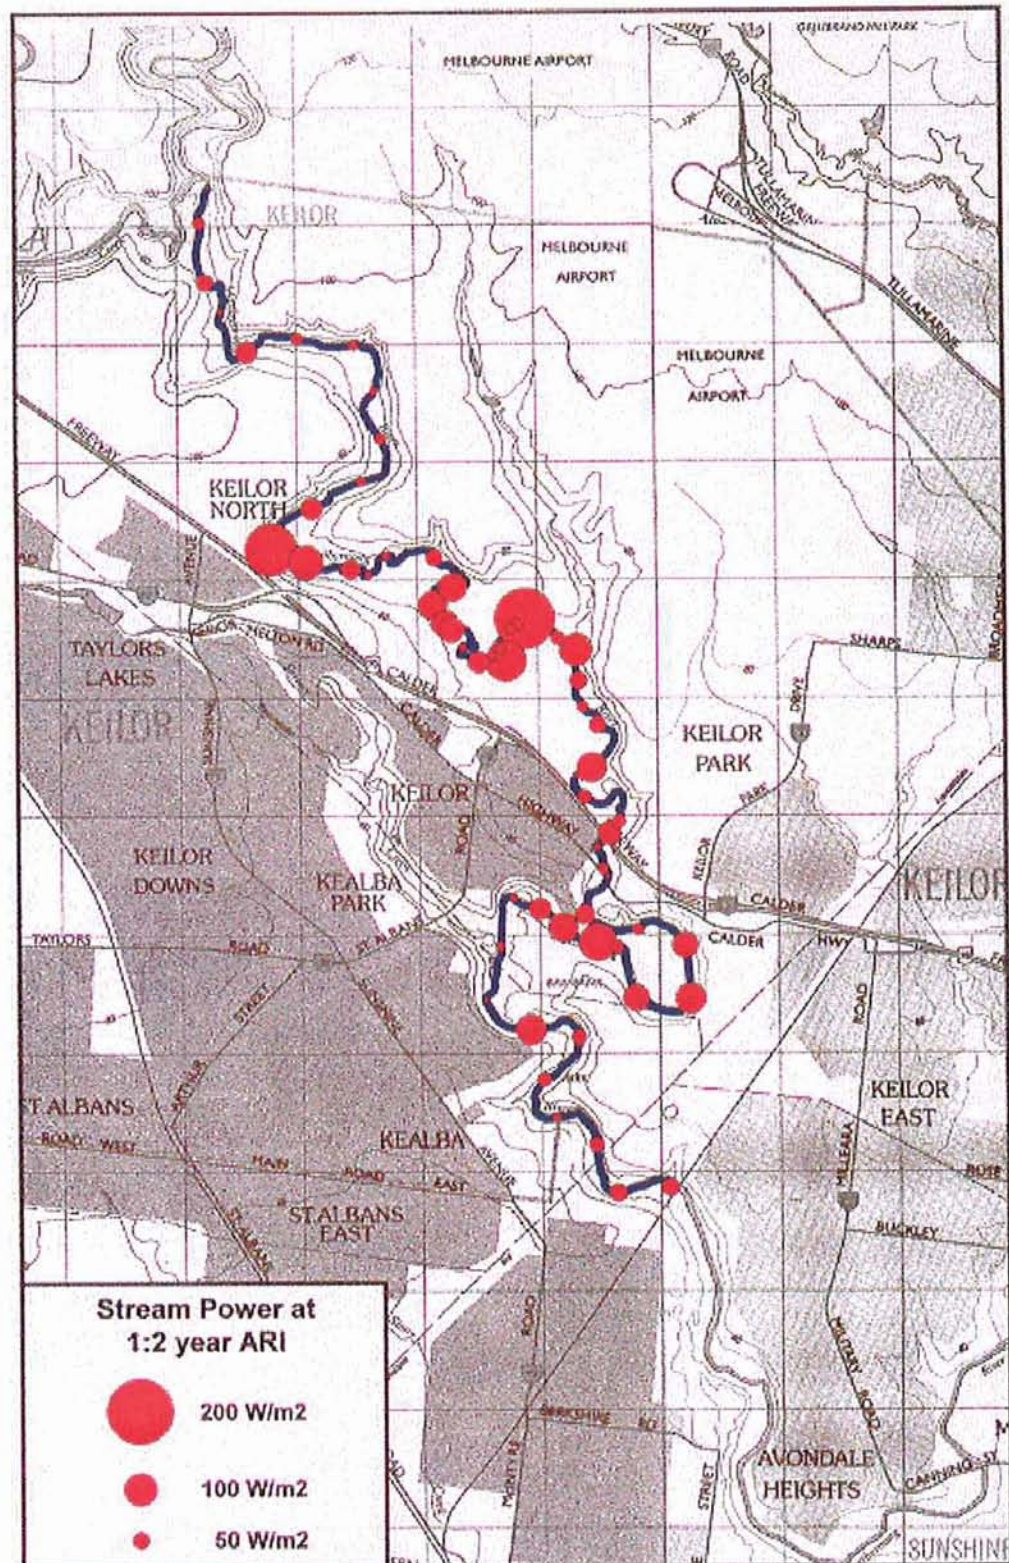
The Maribyrnong River varies considerably in cross-section size and shape, and slope over this section, and this gives rise to considerable spatial variation in stream power (Figure 3).

**Figure 3. Modelled mean stream power at the 1:2 yr ARI event ( $225 \text{ m}^3 \text{ s}^{-1}$ ) at 62 cross-sections on the Maribyrnong River.**

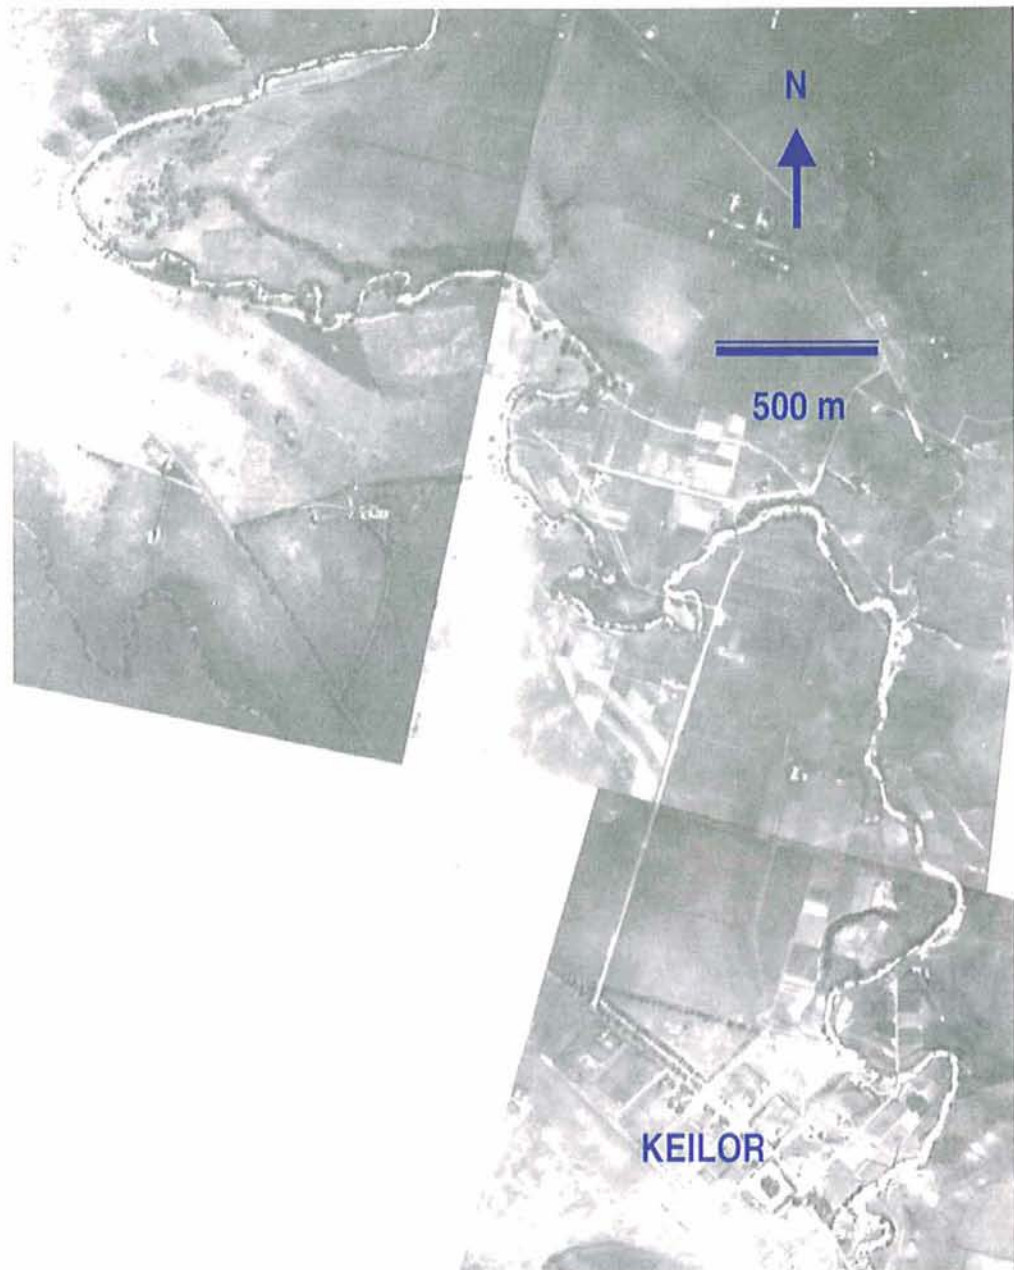
After European settlement, the alluvial flats became the focus of intensive agriculture, which altered their character. A major change was the loss or severe reduction in riparian vegetation. Originally, the banks would have been wooded with River redgum (*Eucalyptus camaldulensis*) and a thick understorey (including river bottlebrush *Callistemon sieberi*). Of the 233 plant species recorded in the Keilor reach, 52% are exotic (Fisher, 1999). The original vegetation would have added considerable strength to the bank material. The channel would have had a high loading of large woody debris, which would have added stability to the bed. Although the Maribyrnong River would always have been fairly active in its alluvial sections (due to high stream power and active geological downcutting), disturbance of the riparian vegetation would have accelerated the rate of channel change. At the time of the first aerial photograph taken on 13<sup>th</sup> April 1931, the floodplain and riparian zone had been almost completely denuded of trees (Figure 4).

**Figure 4. 1931 aerial photograph of Keilor reach of Maribyrnong River (MMBW Aero 2,13/4/1931, Runs 15, 16 & 17. 12:00 hrs No. 03452).**

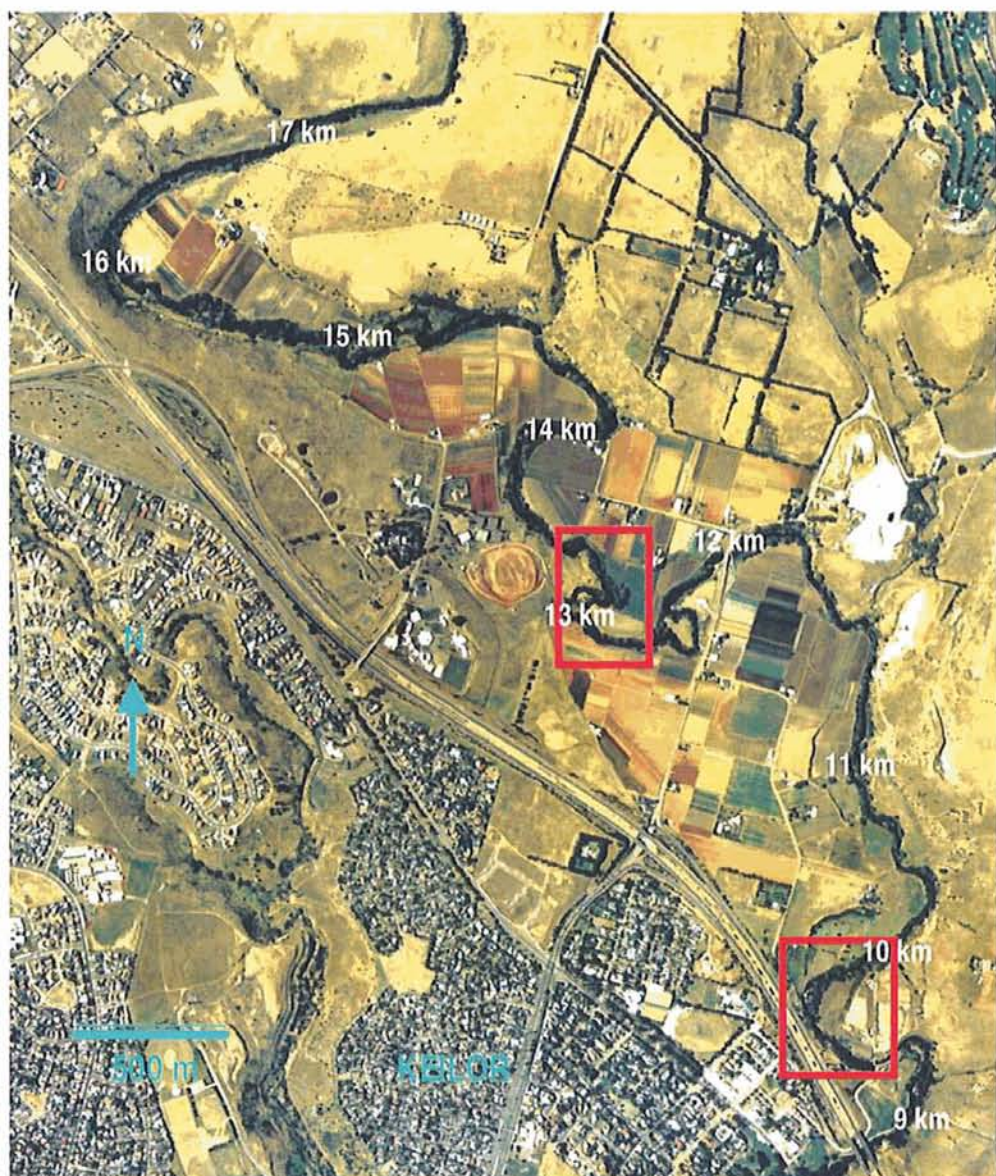
The Maribyrnong River was surveyed in 1852. Since that time the course of the river has been altered along three sections, all of which involved shortening of the river by meander cutoff. The oldest of these cutoffs are located at chainages 9.87 to 10.1 km and 10.75 to 11.15 km (Figure 5). The cutoffs apparently occurred sometime between 1890 and 1926. The most likely initiation date is the record flood of 1906, as the cutoff channels were heavily silted up by 1926 (Camp Scott Furphy 1990). The upper cutoff reduced river length by 260 m, and the lower cutoff reduced it by a further 300 m. This represents 20% of the river length between the site of the lower cutoff to Arundel Weir (which ultimately controls headwards bed erosion). The rock bars present in this reach probably limited downcutting, so some bank erosion probably followed the meander cutoffs.

**Figure 5. 1993 aerial photograph of Keilor reach of Maribyrnong River.** Chainage is zero from Railway Trestle Bridge. Framed reaches are magnified in Figs 25 and 26.

Following the report of Camp Scott Furphy (1990), approximately 1000 m of river bank (representing 5 sites) were treated at a cost of \$1M (Fisher 1999). Camp Scott Furphy (1990) recommended soft engineering solutions such as timber groynes, but site difficulties deemed this approach impractical. After some initial failures using single sized rocks placed over geotextiles, the favoured technology was to first batter the banks, lay down a 300 mm thick filter layer of crushed rock, then key in larger rocks of mixed sizes. Topsoil was placed across the upper rock work. The crushed rock filter allowed riparian plants to recolonise. The five sites treated to date are (see Figure 5):

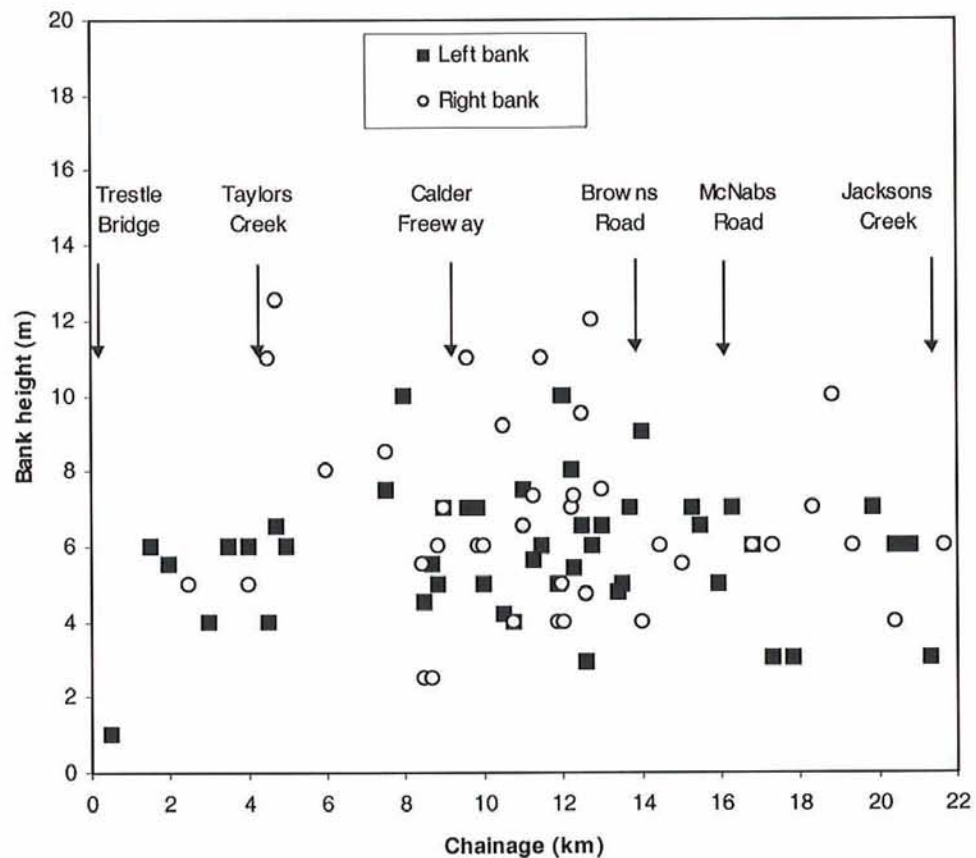
The active alluvial banks of the Maribyrnong River were quite high in many places (Figure 14). The angle of the banks was generally less than 60°, but a few cross-sections had banks that were near to vertical (Figure 15). On the basis of height and angle, these banks would be classified as susceptible to instability when saturated.

**Figure 14. Maribyrnong River bank height (alluvial banks only) (source: cross-sections, see Table 3).**

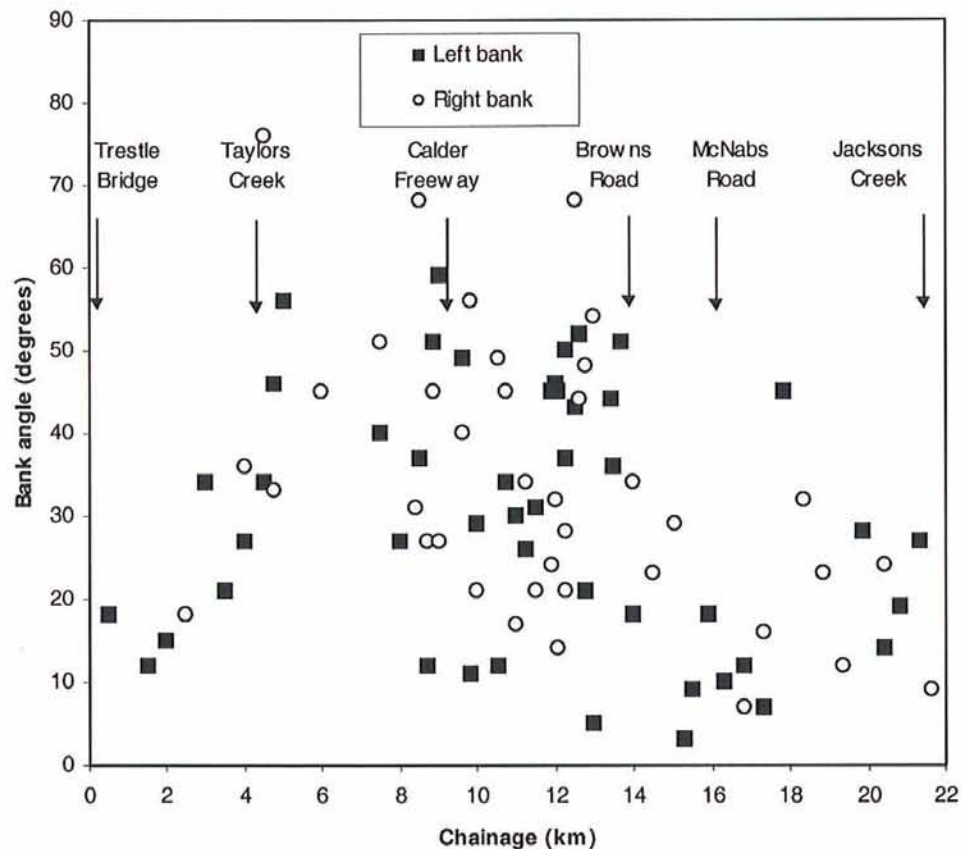
**Figure 15. Maribyrnong River bank angle (alluvial banks only) (source: cross-sections, see Table 3).**

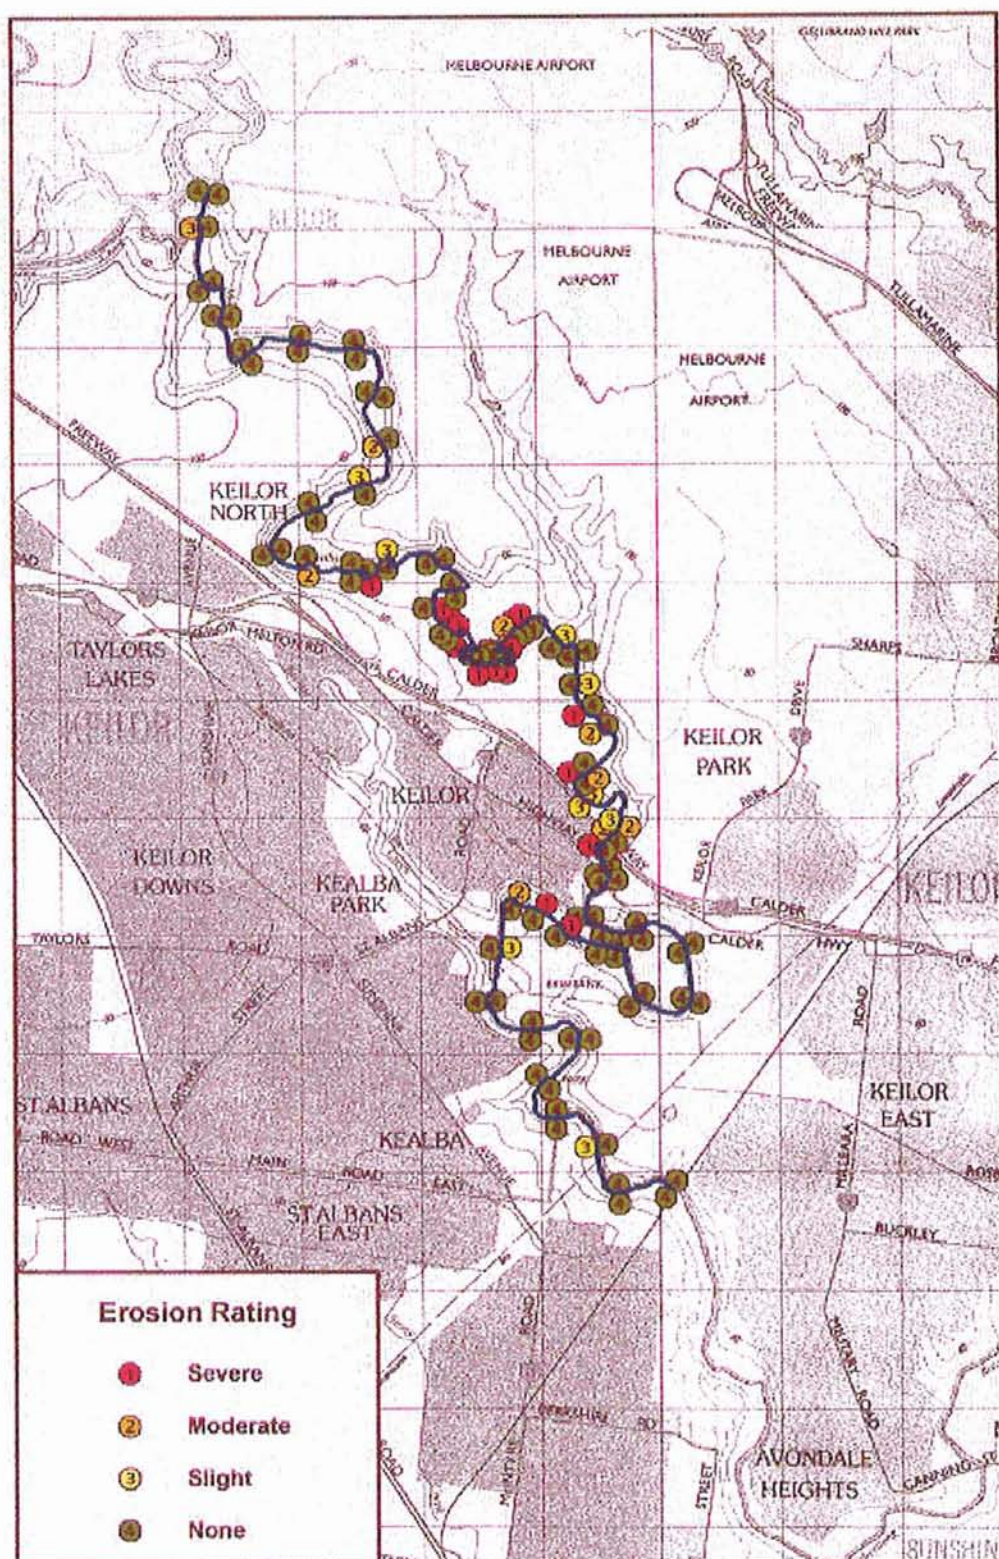
Figure 29. Erosion rating at 62 cross-sections on the Maribyrnong River [source: Camp Scott Furphy (1990)].

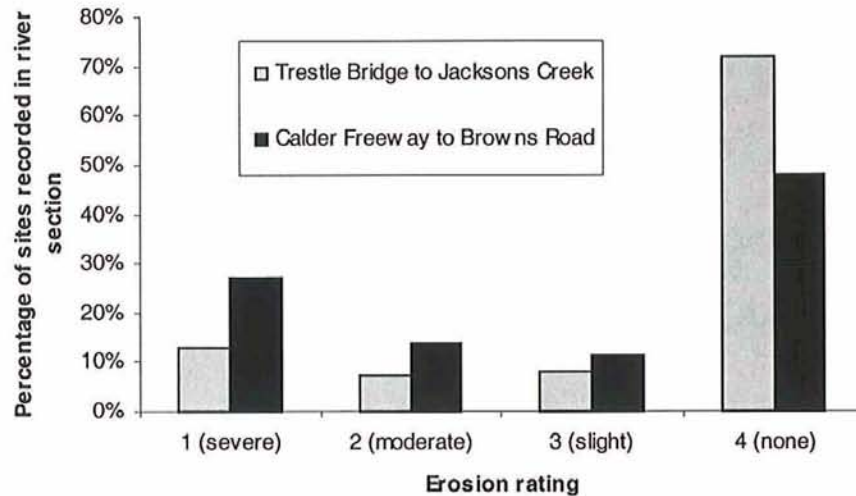
It was not surprising that the alluvial Keilor reach between Calder Freeway and Browns Road contained a higher density of erosion sites, with 27% of sites in this area rated as severe, compared with 13% rated severe for the entire study area from the Trestle Bridge to the junction of Deep and Jacksons Creeks (Figure 31).

**Figure 31.** Distribution of sampled erosion sites for the study area, compared with that of the largely alluvial Keilor reach from Calder Freeway to Browns Road.
