## Project 4.4 : Prioritisation and effectiveness of rural land runoff control interventions

### Assessing the performance of sediment ponds and swales at Beenak

March 2016

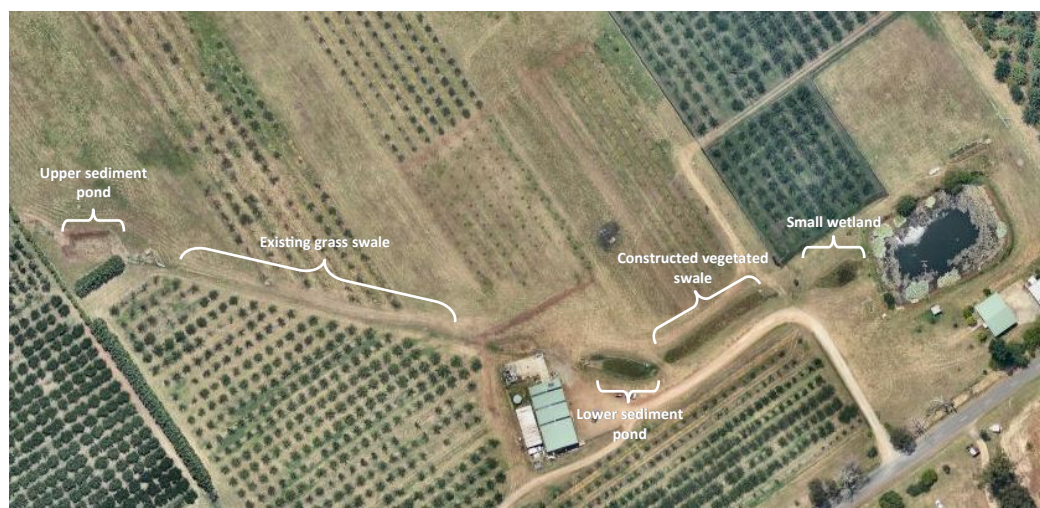
Figure 1: Site map showing the location of treatments systems at the Beenak site.

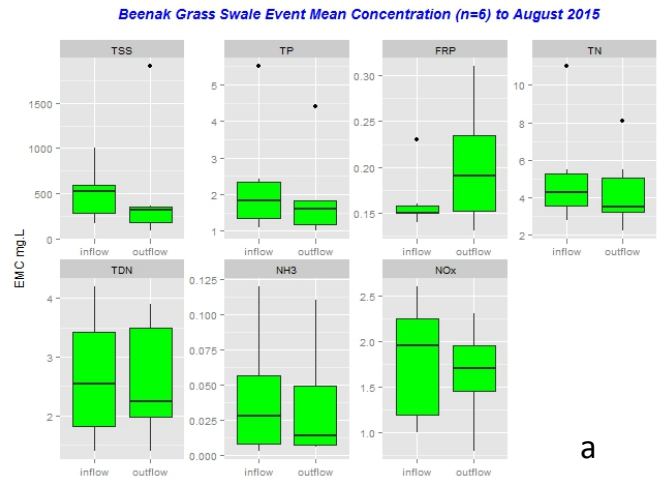
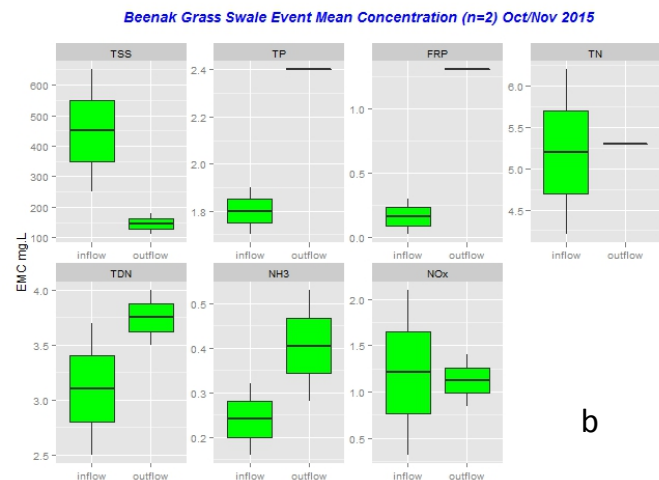
Figure 2: Mean concentrations from the grass swale for a) the first six samples which had unknown rates of fertiliser application, and b) two collections during which spraying was known to be occurring.

So far, data has been collected over 20 and 12 months for the grass and constructed swales respectively. In that time, eight events were recorded for the grass swale. The first six (when combined) tend to show a slight decrease in TSS, TP and TN (Figure 2a), however, the last two events collected show a reduction of TSS only and an increase in TN and TP (Figure 2b). This is likely a result of the overspray during the landholder's application of "High K" fertiliser.
